Over the past few years we are seeing field reports from OEM's and third-party inspection services that claim sheave grooves that are supposedly worn out and we see by the photos and returns via urgent airfreight that sheave grooves are not worn at all. We actually had one contractor send sheaves for repair that were found to be new. It seems apparent that many do not understand what sheave groove wear is or how sheaves wear in general. This document has been written to address sheave grooving, flame hardening, contour of the groove and groove wear during a sheaves life cycle and explain what to look for during a sheave inspection.

Reported by Michael L Yoakum, Yoakum Technical Consulting LLC Opinions here are based on my experience performing inspection and repairs and working with sheave manufactures over the last 30+ years Last edit 5 June 2017

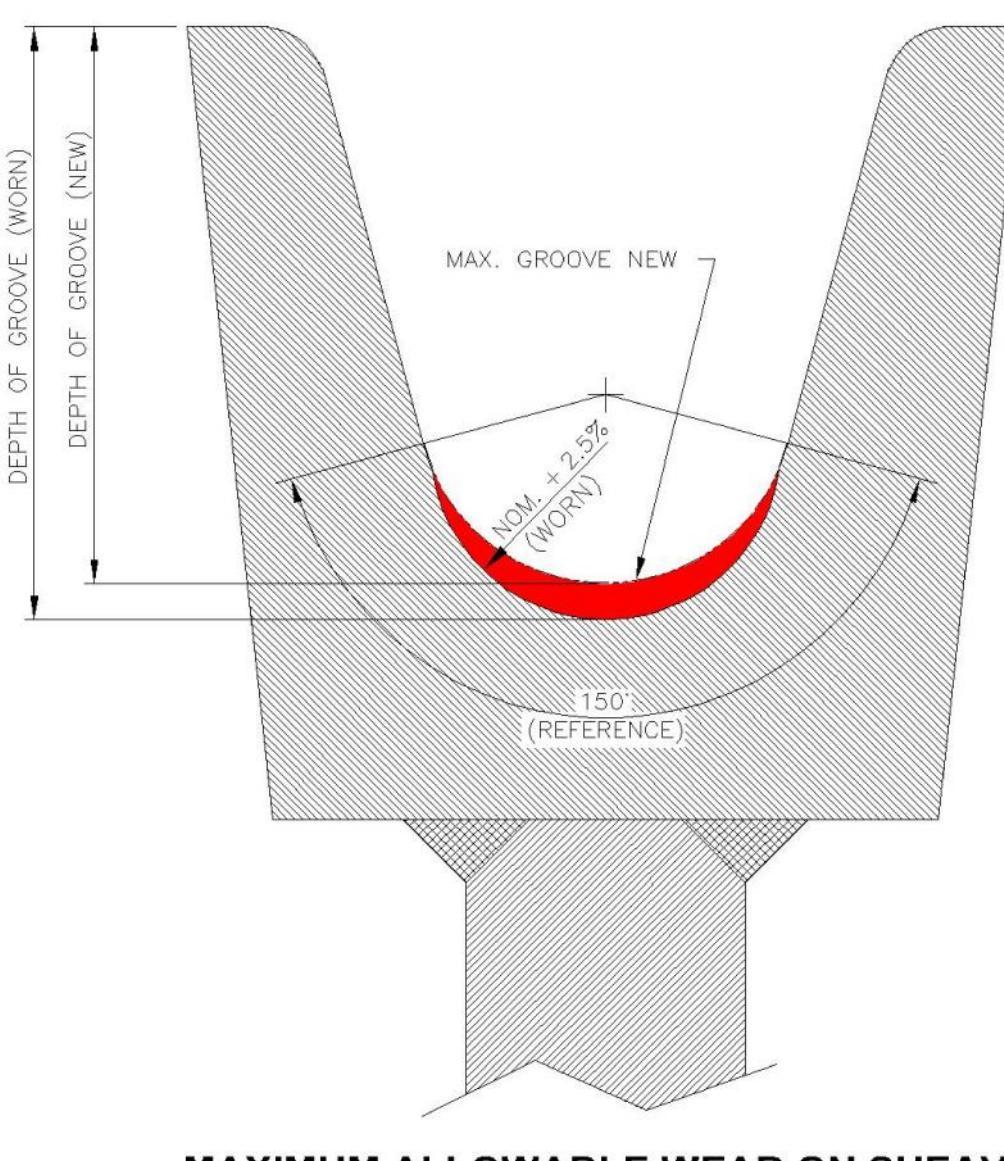
MAXIMUM ALLOWABLE WEAR ON SHEAVE (NOMINAL ROPE DIAMETER + 2.5%)

Here we see a cut away of the standard 3 piece sheave construction where web is welded to a forged ring and a hub (not shown). The maximum new groove width is shown at the top of the red arc. The maximum wear (minimum groove size plus 2.5%) is shown at the bottom of the red arc. The red area denotes the flame hardened portion of the groove and the allowable wear that is normal to a sheave. Note that hardness diminishes as depth increases. Surface may be Rc 40 but within 1.5 mm depth the hardness might be down to Rc 35.

Understanding this we realize that the best way to track and monitor sheave wear is by checking and recording the depth of the groove when sheaves are new as well as checking/recording the sheave groove contour and wear during yearly CAT 3 inspection. Once the depth of groove exceeds 1/8th inch or 3mm over the original manufactured depth, the sheave should be scheduled for replacement.

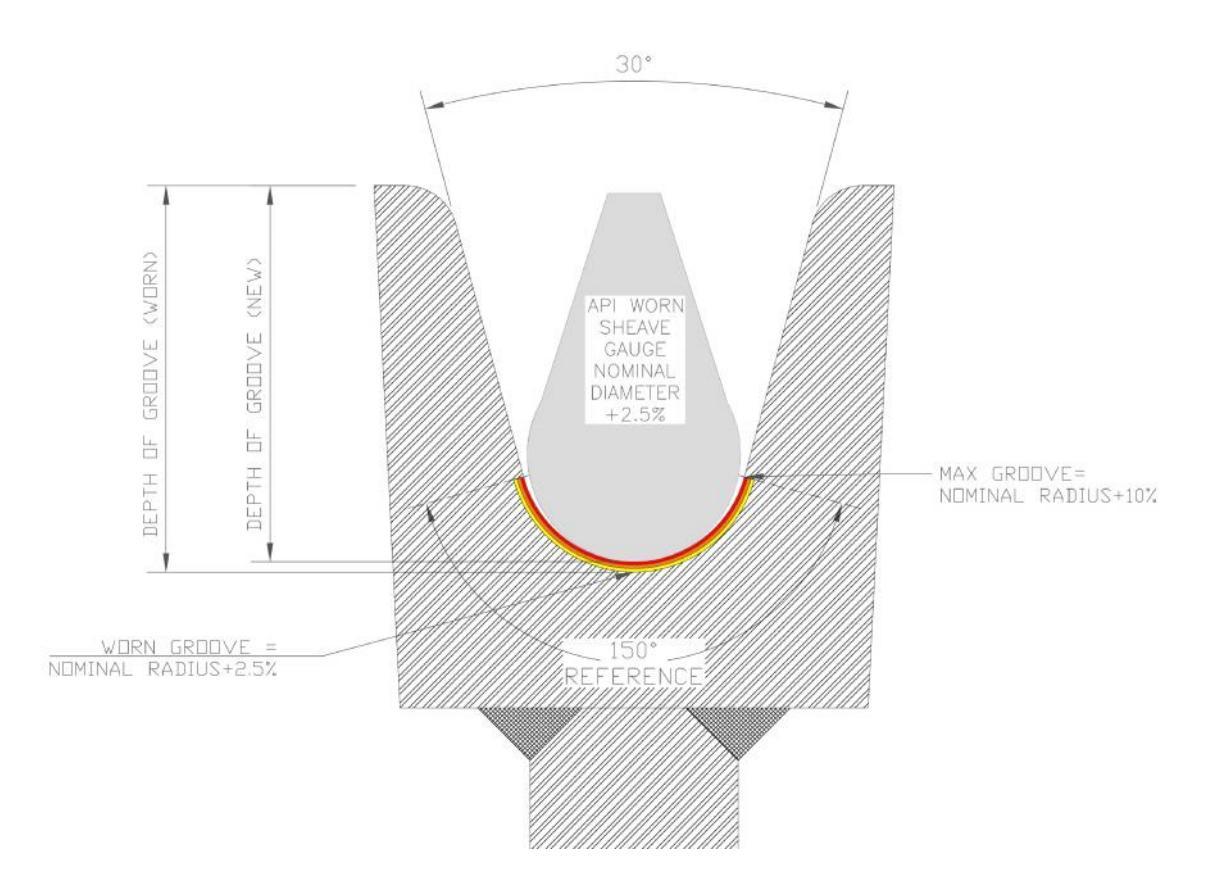
New sheave with API worn gauge

This is normal and sheave groove is as new condition with API worn gauge inserted. Note the groove hardness represented by 3 colors, RED, ORANGE and YELLOW. This is the best way to visualize the hardness as well as critical wear areas on sheave grooves. Radii for new sheaves is nominal +6% to nominal +10% and most manufactures try and machine grooves to nominal+8% as a start point.

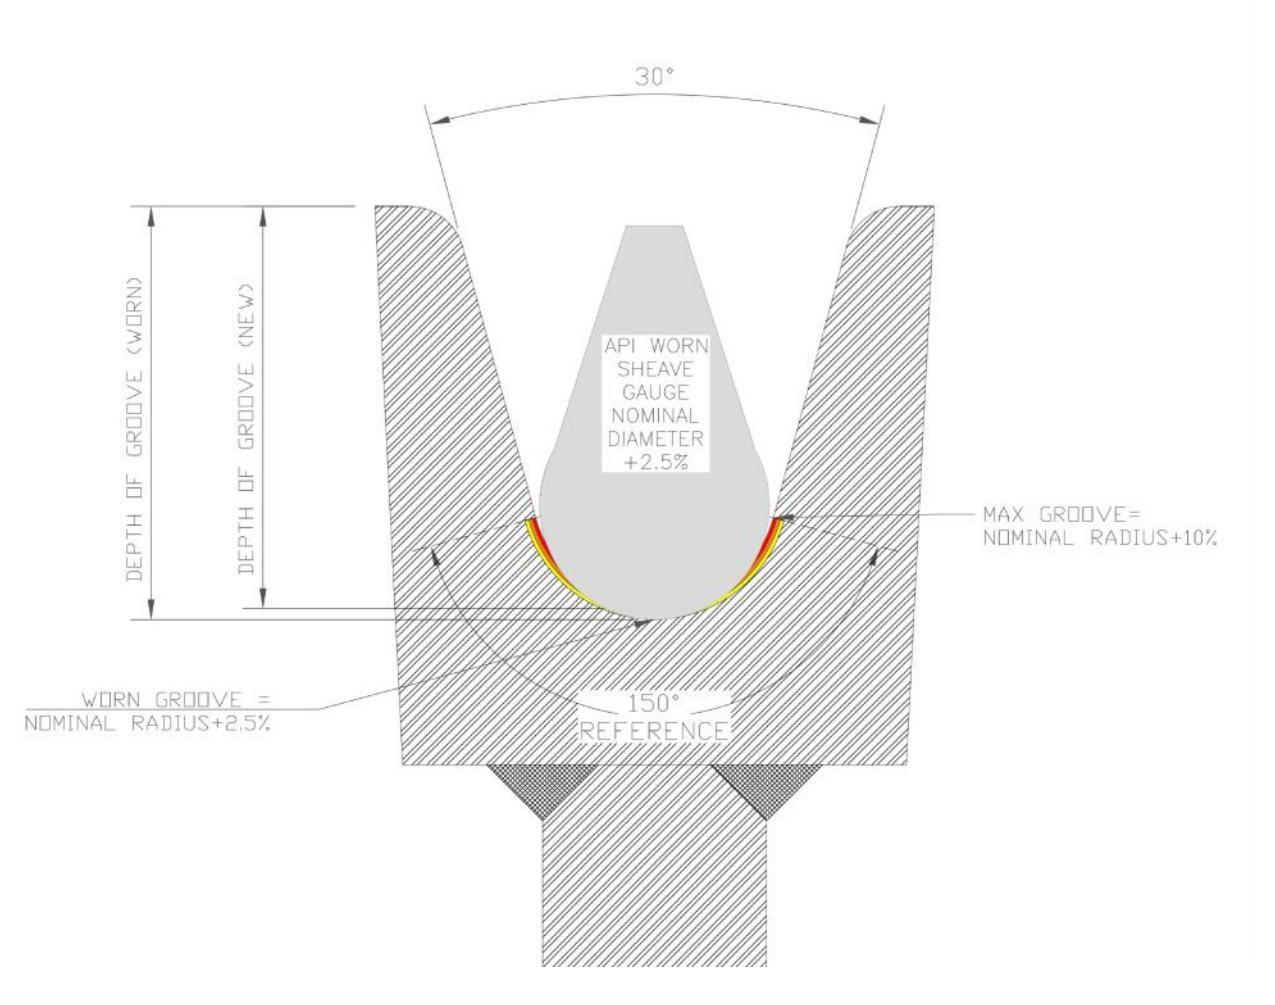
Worn groove with API worn sheave gauge

Here is how an API worn sheave gauge will set in a worn groove below. At this point the original groove hardness is worn away and the sheave should be scheduled for replacement at the next Out of Service Period.

Note that the API worn sheave gauge fits snug and there is no gap along the sides. Had this sheave been checked for depth of groove when new we would now see that the depth had increased around 0.100" or 2.5 mm at this point. This is normally only found on fast line sheaves on block and crown if a good cut and slip program has been followed.

Note here that the hardened area of RED, ORANGE and YELLOW are gone in the center of the groove. Original groove hardness is worn away. It may have taken 10 years to get to this point but additional wear will happen much faster due to lack of hardness. Depending on design and original manufacturing depth of groove, the conventional 3 piece fabricated sheaves can be requalified via inspection and MPI, regrooved and re-hardened and reused.

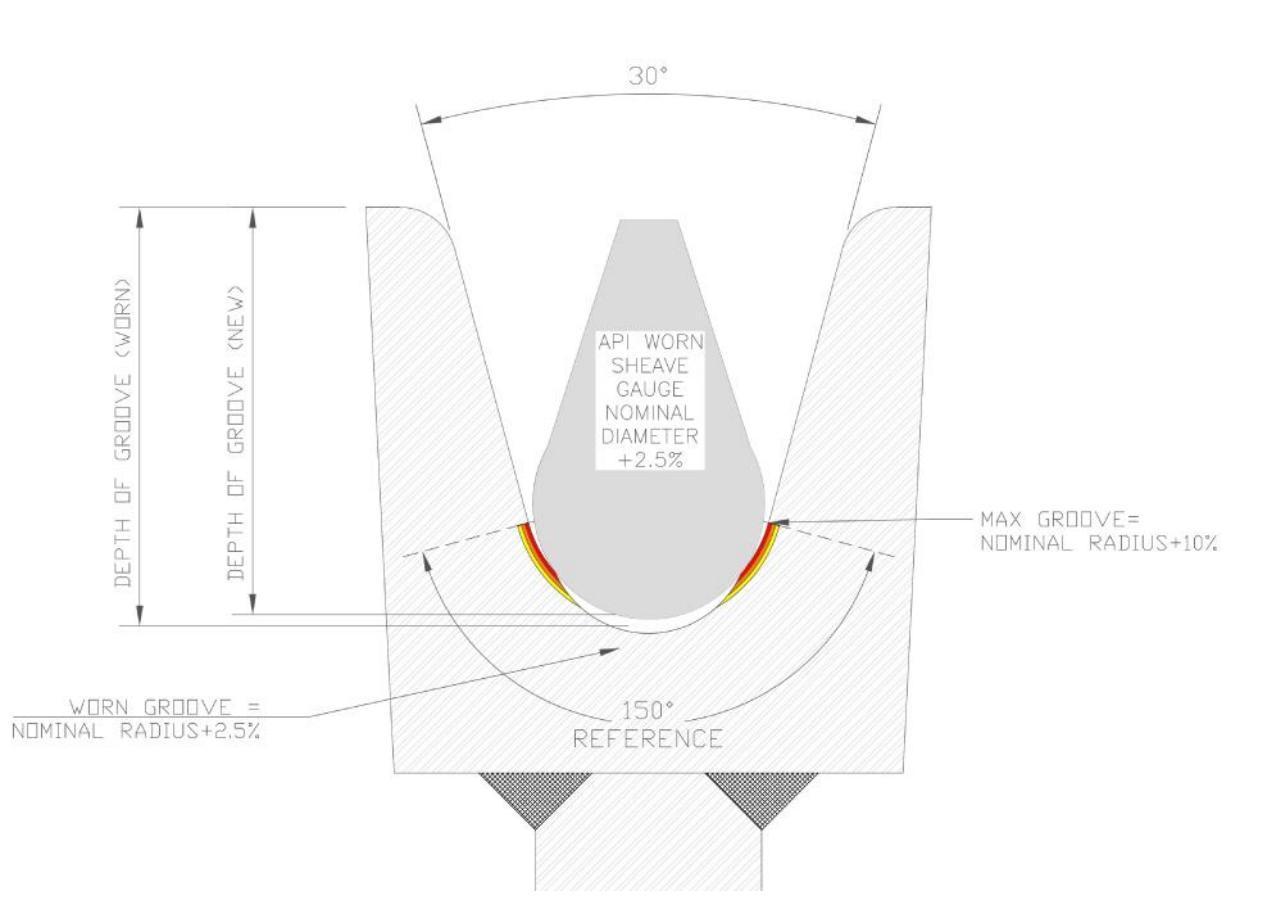
Severely worn sheave groove with API worn gauge

Below we see an API worn sheave gauge in a sheave that is excessively worn and should be removed from service at the next opportunity. In this case the groove width is adversely affecting the integrity of the wire rope due to pinching and high stranding. This has normally been seen in derrick traveling assemblies on the fast line sheaves closest to the Drawworks and is usually caused by a poor cut and slip program.

This is the condition we find when we are requested to inspect sheaves due to premature wire rope strand breakage and the root cause is found to be sheave wear. That is an important point, today issues with wire rope wear has nothing to do with the sheaves or the sheave grooving.

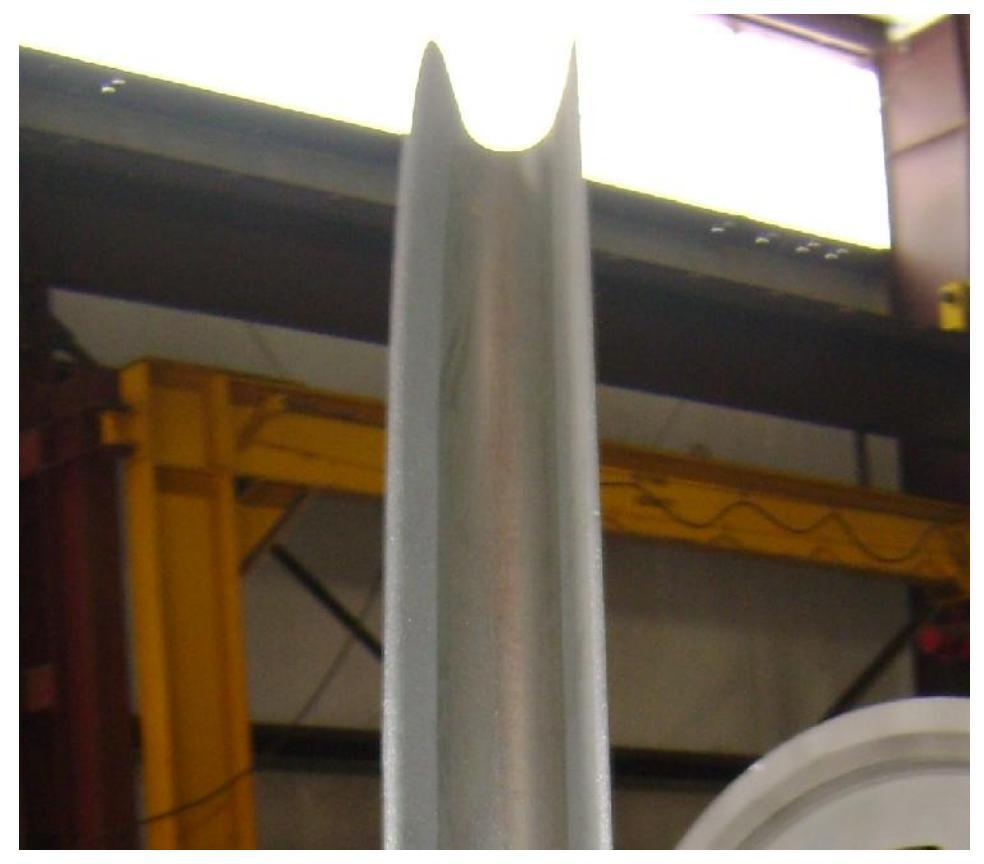
Fleet Angle Wear Here we have some severe wear from excessive fleet angle. This was a traveling block sheave that was in use with a retract dolly system.

This sheave was next to the one skipped, it dealt with the fleet angle from dolly retract plus and additional 6 inches of fleet angle due to the skipped sheave not used in reeving.

The conservative opinion is that when found in this condition these sheaves should be scrapped. We have seen contractors flip them to allow wear on the other side. We do not consider this advisable under most circumstances but if the sheave passes MPI in flange welds as well as the groove area it is acceptable for use if groove is within API allowable and the sheave is flipped. In this case MPI of the groove area would be important to look for any fatigue cracking from loss of material which may occur.

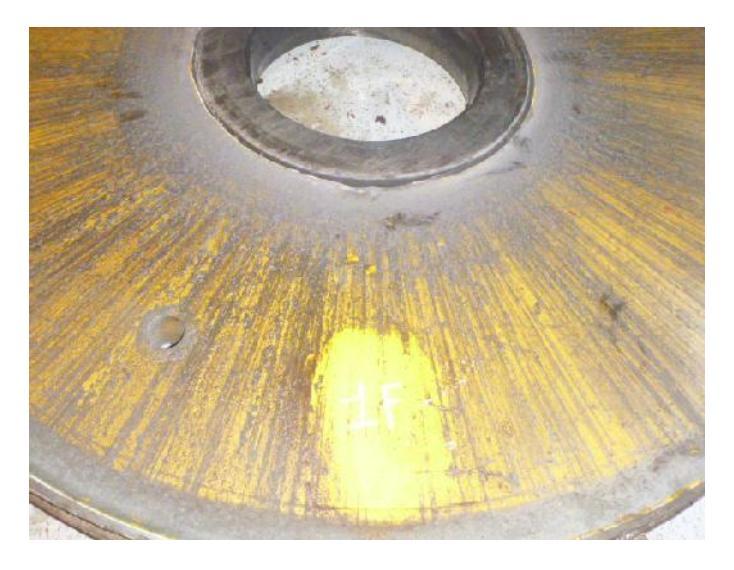
Above we see a dual web hub failure, it also appears there is a faint line at the bottom of the groove where it is staring to fail.

To stop any chance of receiving dual web sheaves always stipulate in the PO that sheaves must be manufactured to API-8C PSL-2 spec. This will give you the best chance of not receiving this style sheave which is being pushed by both primary equipment OEM's as their standard.

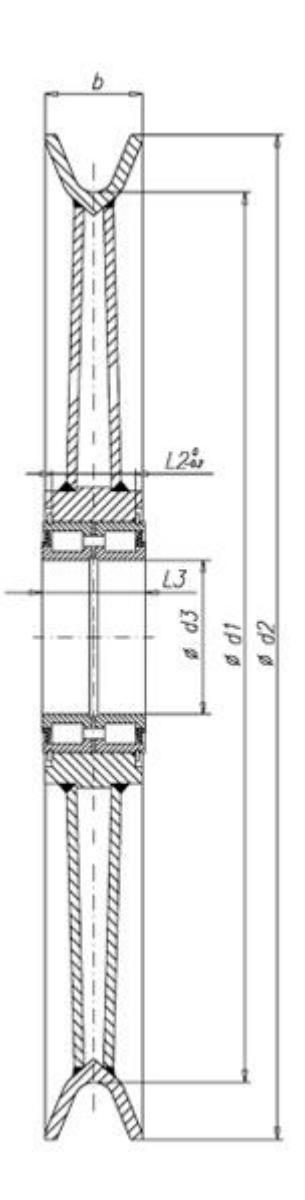
To the right we see a cut away of the dual web design, welds at flange to groove and hub areas are small fillet. None of these design sheaves could be manufactured to API-8C PSL-2 specification which requires full penetration welds.

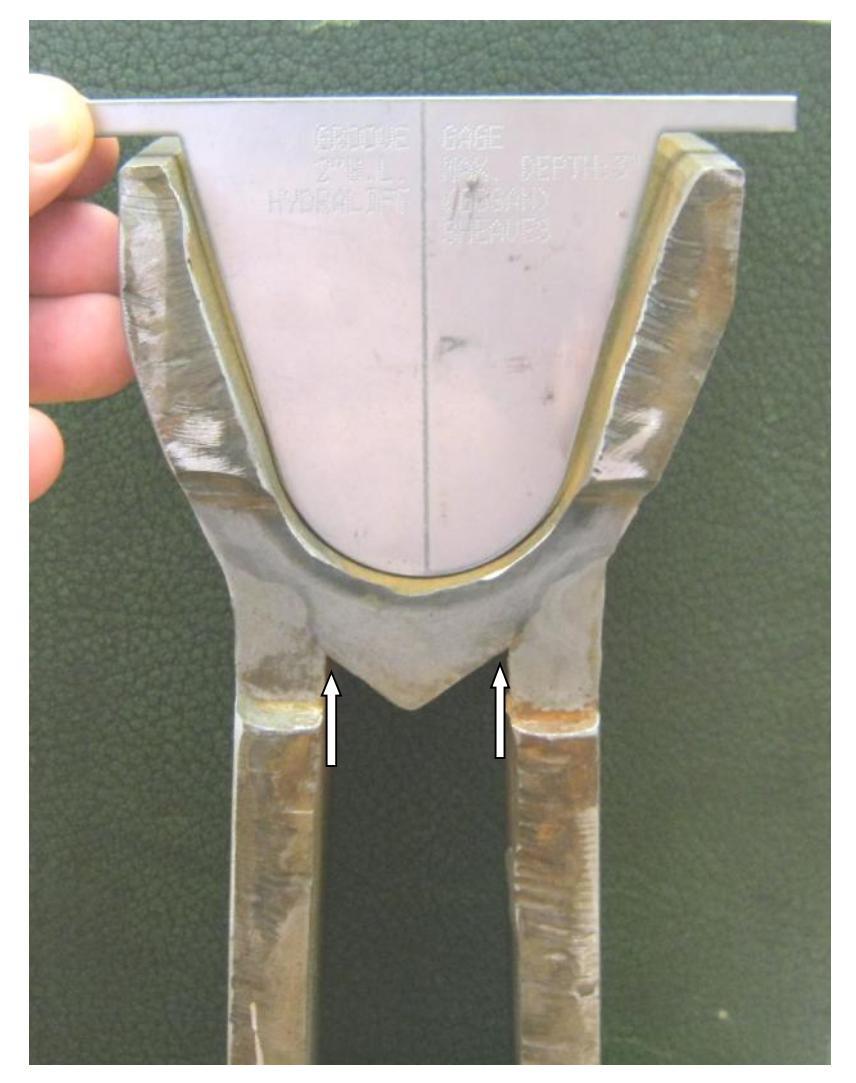
Duel web sheaves due to design (as seen below) do not meet the criteria for remedial repair; there is not enough material in the bottom of the groove to allow for wear let alone rework

Cut away of a dual web sheave with No-Go gauge depth set at 1.5 times rope diameter.

This style sheave should be removed and replaced when found, these dual web sheaves appear to be designed to wear out within 10 years or less. This cut away we found cracks starting at both webs inside. Also hardness depth can be seen in the bottom of groove discoloration.

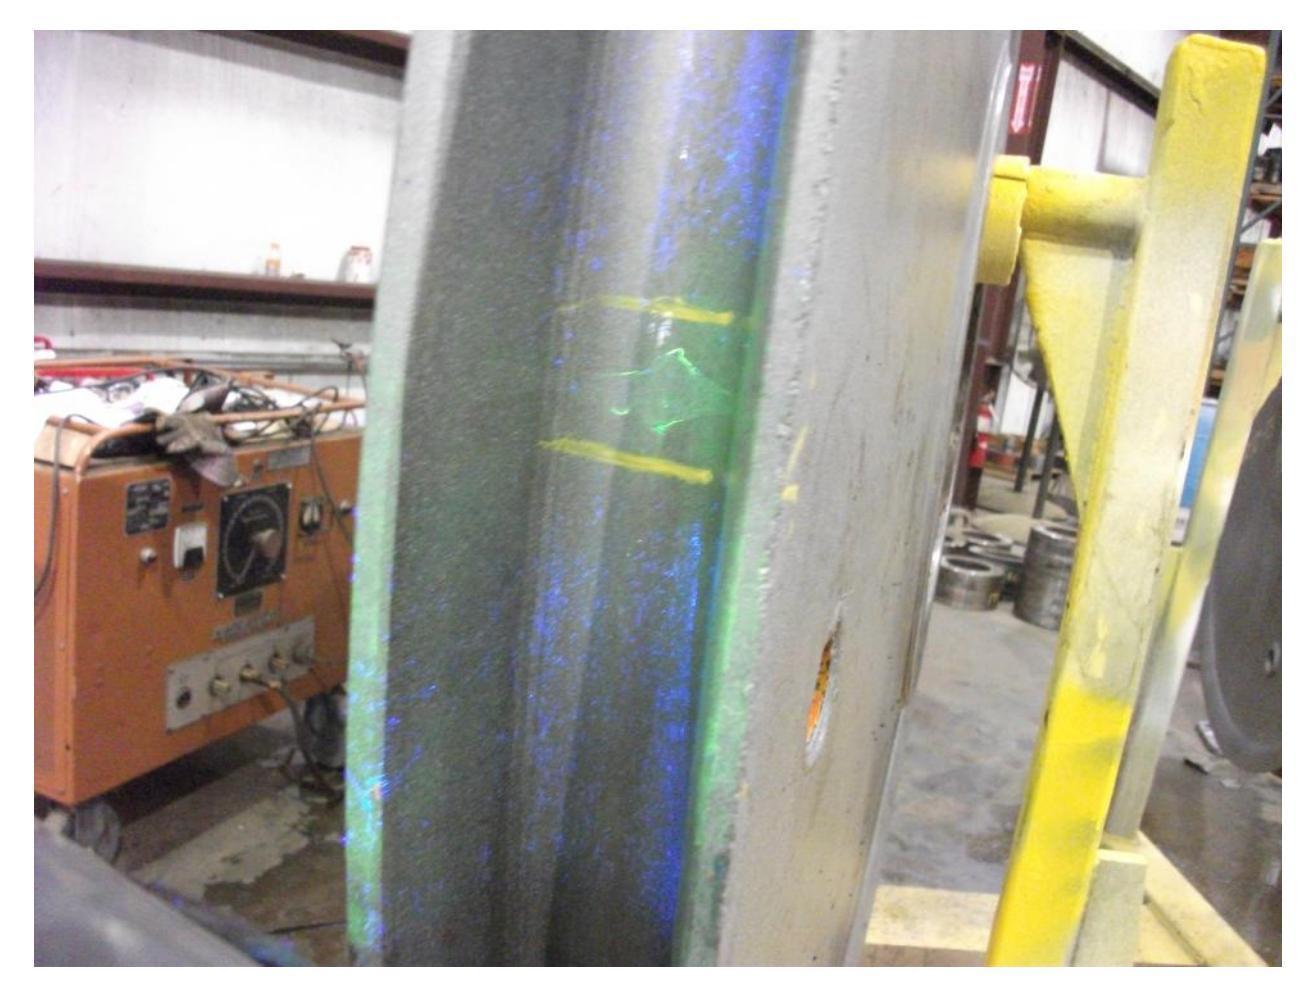
We have also noted during CAT 4 inspections on Dual web sheaves that many of them the groove is made from rolled and welded angle bar and the weld where it is joined together usually always has a transverse crack running through the groove.

Here you see the transverse indication and look closely at left flange and you can see it has been hand ground to match up the transition on the ends.

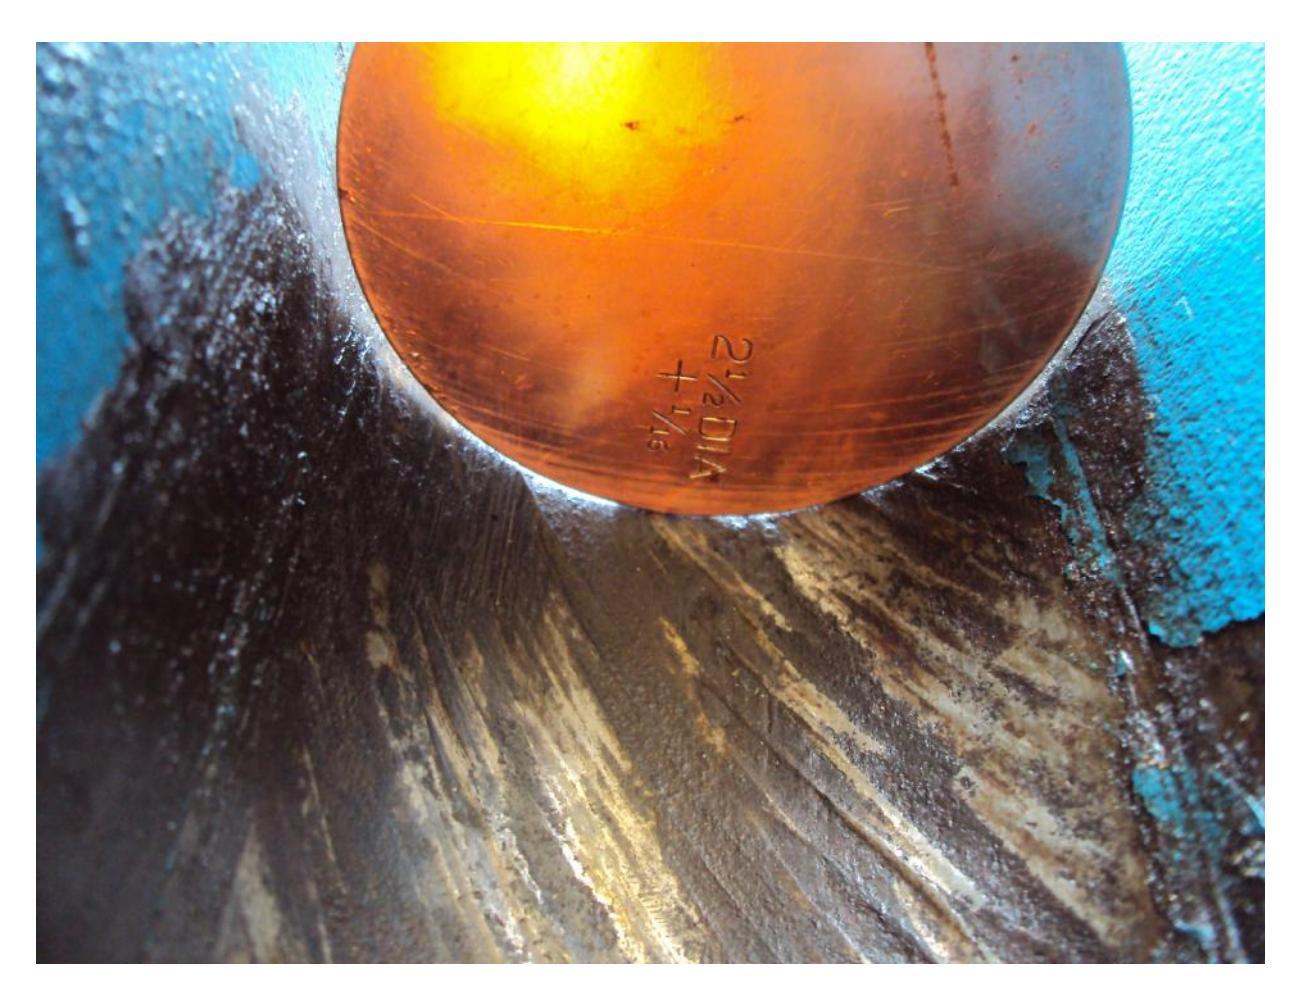
Sheaves in Marine Riser Tensioners, (known as MRT or Tensioner sheaves) and turn down sheaves do not follow normal wear sequence as sheaves in traveling assemblies. The MRT sheaves tend to spend a lot of time rocking back and forth. This has shown over time to cause the groove to pick up the rope impression in the bottom of the saddle as seen in the below photos.

Here we see a sheave that the groove checks good for width but the surface finish is badly damaged from wire rope. Many times these sheaves can be repaired by regrooving and re-flame hardening but that has to be done in a shop by people who are familiar with the procedures.

In all cases with standard 3 piece sheave construction we were able to repair these sheaves after they were qualified by blast, dimensional inspection and passing NDT. The grooves were then re-cut 1/8th inch deeper or until the marks and pits were removed. In no case did we allow a re-cut depth greater than 1.5 times the rope diameter and in no case, did we have to.

Sheaves were then flame hardened again and put back in service.

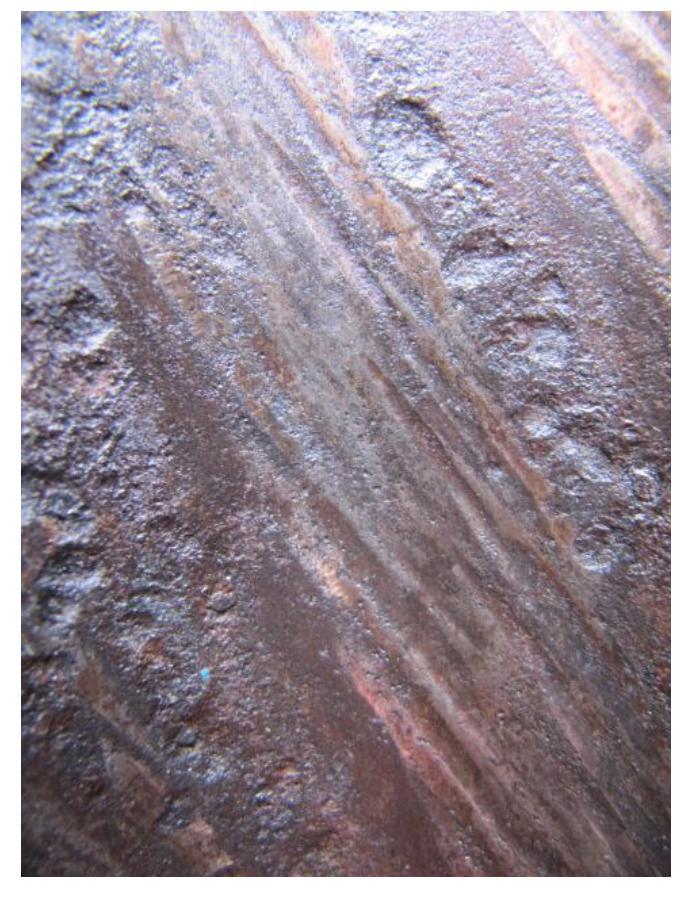
Here again in this close up we see wire imprint into the groove and corrosive pitting; this is an MRT sheave.

The technical term here is "negative imprint"

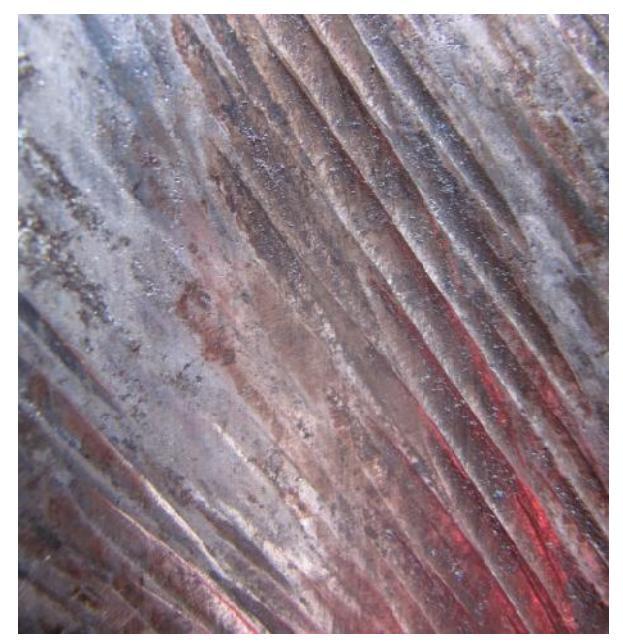
Below we see corrosive pitting as well as faint imprint.

Both of these conditions will have adversely affected the life of the wire rope.

This will usually show up as breakage or wear of the individual rope strands and premature rope failure.
